AGING TEST REPORT

Customer: MUROS SINTÉTICOS DECORATIVOS, S.L.

Sample tested: Decorative wall panel imitating concrete M3

Their reference: Hormigón / Concrete Panel M3
Our reference: P-09-10776/2-A-2

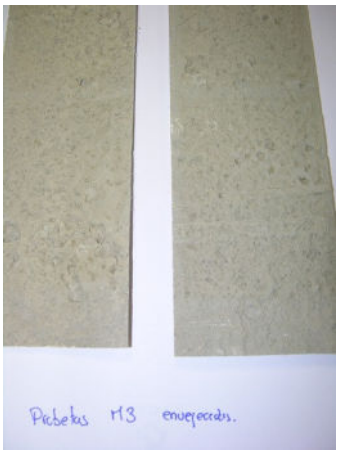
Look at the photos after the first cycle 500h:

In that case it is manifested in yellowing resulting in the parameters analyzed:

After have completing the 1000 hours of exposure it was not observed any discoloration occurred at higher than the initial phase of 500 hours.
